# SEA GRAPE TRIMMING AND SEA TURTLES

# SEA GRAPE TRIMMING GUIDELINES

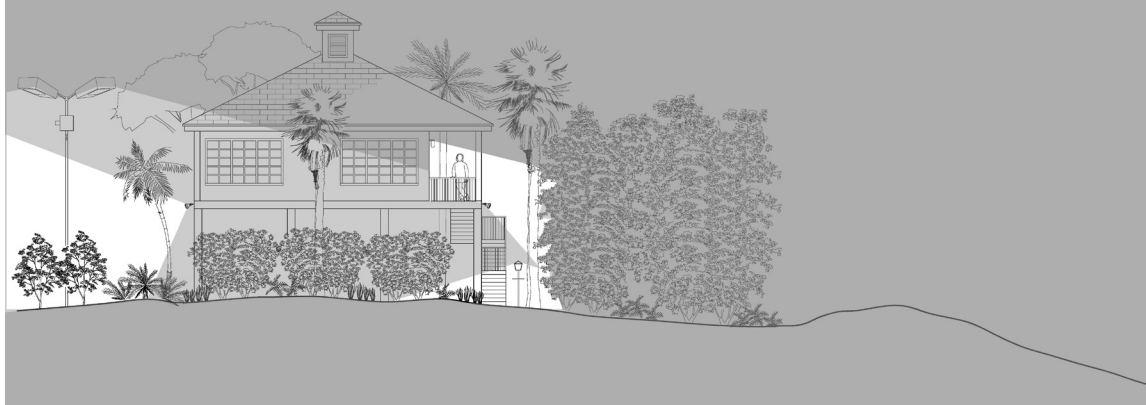
## BEFORE SEA GRAPE TRIMMING

This diagram depicts a beach house with several styles of exterior lighting. These lights are shielded from the beach by a large stand of sea grape, *Coccoloba uvifera*. The homeowner would like to trim this stand of sea grape to improve the

view from the balcony but is concerned about light trespass onto a sea turtle nesting beach and potential liability should these lights cause the disorientation and deaths of protected sea turtles.

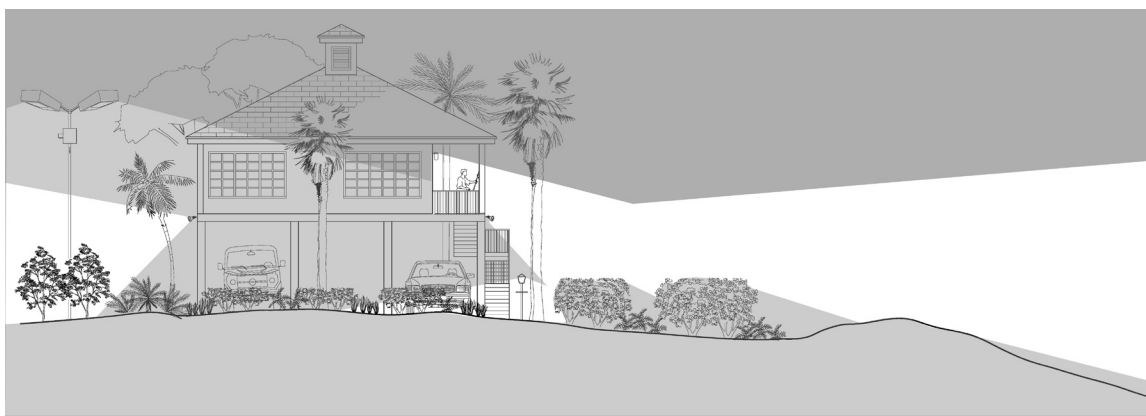
## BAD SEA GRAPE TRIMMING

Here, the homeowner has over trimmed the sea grape stand. Although the homeowner now has a better view of the ocean, light pollution now shines onto the nesting beach disrupting normal sea turtle nesting behavior. Of particular concern are the poor light fixtures, car headlights and now the streetlight

are also visible from the beach. This unpermitted trimming damages the sea grape stand, disrupts sea turtle nesting and exposes the homeowner to potential legal action including substantial fines.

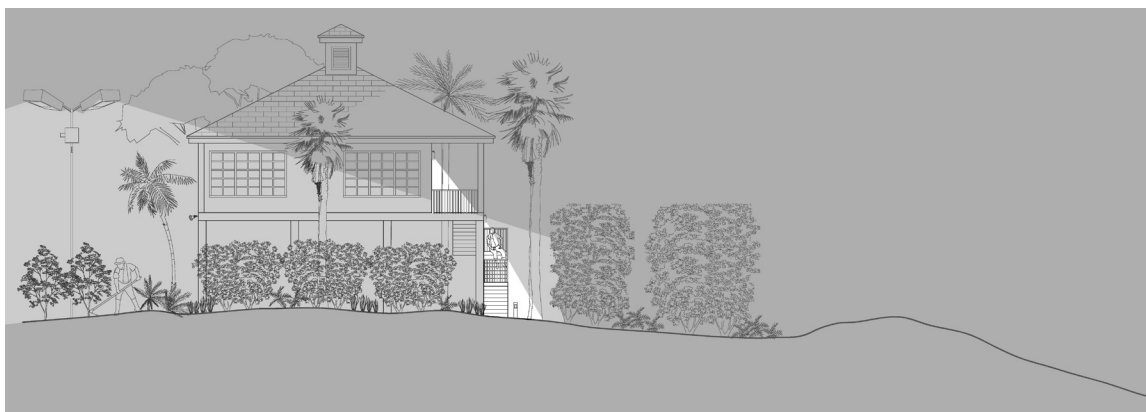
## APPROPRIATE SEA GRAPE TRIMMING

The trimmed seagrape stand now allows a view of the ocean from the balcony. Realizing this would make the balcony light visible from the beach, the homeowner has replaced the jelly-jar light with well shielded canister downlight equipped with a FWC approved 3watt to 12watt Amber LED lamp. The

homeowner has also replaced the floodlight on the beachside of the house with another canister downlight and bollard fixture with downcast horizontal louvers to illuminate the stairs for safety. Even after trimming, the homeowner has actually reduced illumination visible to the nesting beach.
